DISTRICT 2 COAL MINE NEAR MISS

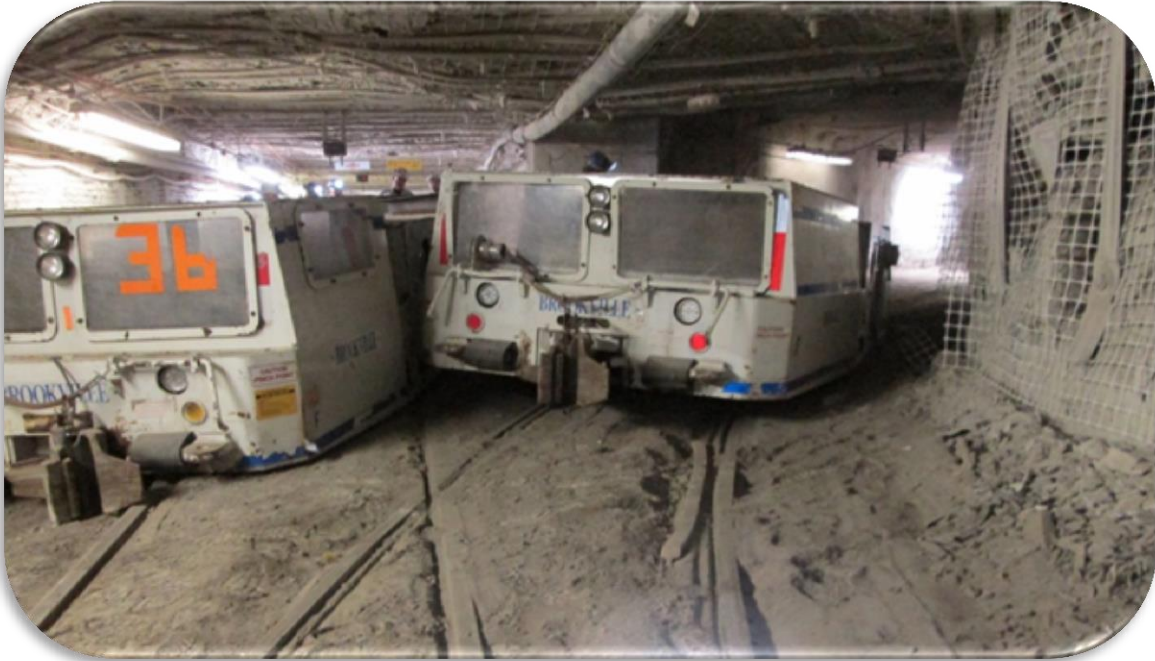
On July 30, 2015 a miner was seriously injured when the track mounted mantrip, in which the victim was a passenger, collided with a second mantrip that was entering the main track from a side-switch. The victim's foot was caught between the two pieces of equipment resulting in crushing injuries that led to the amputation of three toes.

- Keep all body parts inside of equipment while it is in motion.
- Check for oncoming traffic before proceeding through a track switch.
- Train equipment operators to obey established traffic rules.
- Stop / Look / Analyze / Manage (SLAM) work areas before proceeding.
- Establish and discuss safe work procedures before beginning work. Identify and control all hazards associated with the work to be performed and the methods to properly protect persons.
